Floating booms to prevent blue-green algal scums and other floating debris from fouling Madison area swimming beaches: a pilot test

Richard C. Lathrop, Wis. Dept. Natural Resources

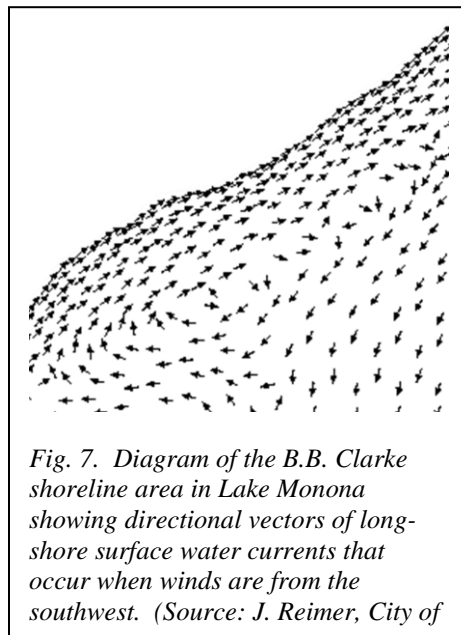
Fig. 7. Diagram of the B.B. Clarke shoreline area in Lake Monona showing directional vectors of long-shore surface water currents that occur when winds are from the southwest. (Source: J. Reimer, City of

B.B. Clarke Beach. The 3-sided deflector boom system worked well at B.B. Clarke Beach (Figs. 3, 6) during all three summers of boom deployment in 2010-2012 because this beach is often exposed to long-shore water currents (Fig. 7). Beach users and lifeguards during informal interviews felt the beach was much cleaner with high public acceptance of the boom system. However, in 2010 the popular diving platform was not installed in deeper water beyond the boom endwall due to concerns that lifeguards could not easily traverse the boom wall if an emergency occurred. Experience showed that the boom wall was not a barrier (even acting as a safety float) such that diving platform was installed in subsequent summers.

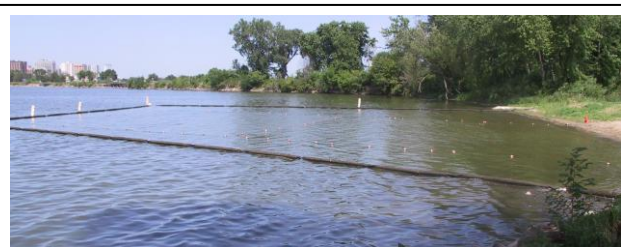
Fig. 8. Deflector boom system deployed at Bernie's Beach, June-August 2010-2011. (Photo: R. Lathrop, WDNR)

Bernie's Beach. The deflector boom system deployed at Bernie's Beach (Fig. 8) during the summers of 2010-2011 maintained the swimming area relatively free of algal scums and other floating debris. Because of the more sheltered and restricted location of the beach area in the corner of Monona Bay, the two sidewall booms were attached to shore with outside wall angles only slightly greater than 90 degrees. Floating material was often observed trapped outside the corner of the west sidewall boom (Fig. 9).

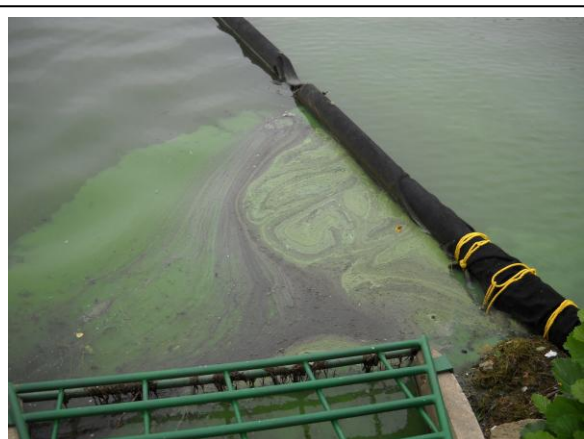
Fig. 9. Algae scum and other floating debris trapped outside the sidewall boom at Bernie's Beach, July 2010. (Photo: G. Steinhorst, City of Madison Engineering Dept.)

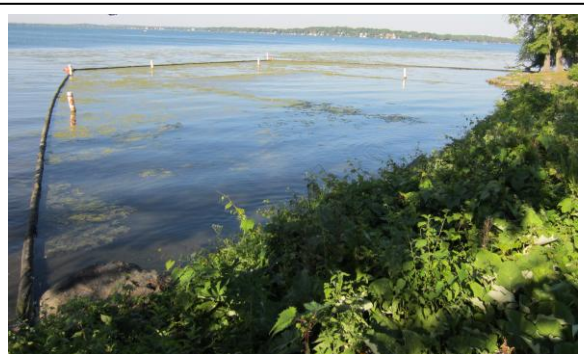
Fig. 10. Deflector boom system deployed at Olin Beach in 2012 showing aquatic plants and filamentous algae growing inside and outside the boom system. (Photo: R. Lathrop, WDNR)

Olin Beach. The deflector boom system tested at Olin Beach on Monona's southern shoreline in 2012 did not work particularly well even though the boom system itself was a good fit for the beach (Fig. 10). The main problem was the swimming area inside the boom system was very shallow with a significant amount of aquatic plants and filamentous algae growing from the lake bottom. Some effort was made to clear out this area with a weed harvester prior to installing the boom, but the filamentous algae quickly grew back into thick masses that created unappealing swimming conditions at the beach. This southwest beach shoreline often was on the upwind end of the lake where water currents could not remove the floating material trapped outside of the boom walls.
